**Inspection Report – Seaboard Solar Development Project**  
**Houghton Hill Road/Scott Road, Town of Homer**  
**July 31, 2026**

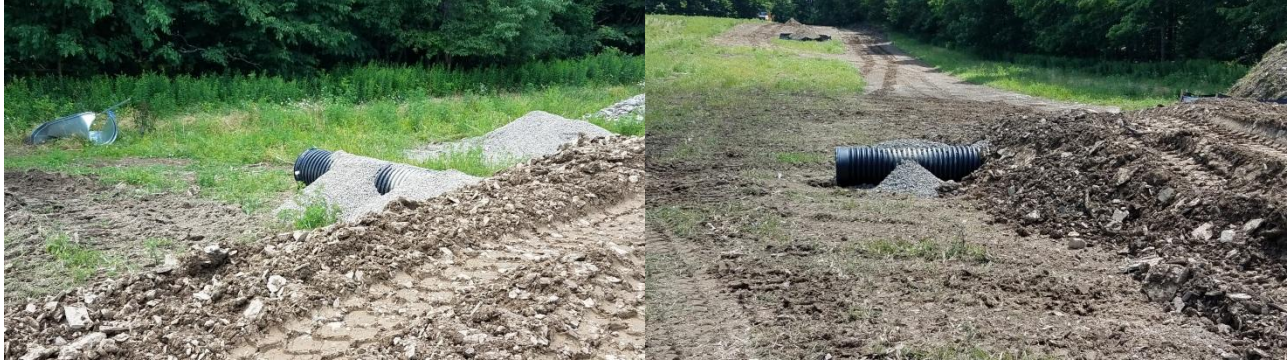
Installation of a second culvert pipe under the access road has started. This pipe is much further up the site as you travel from the construction entrance from the west to the east of the site. This pipe is located east of the jobsite trailer and fuel tank.

Second Culvert Install

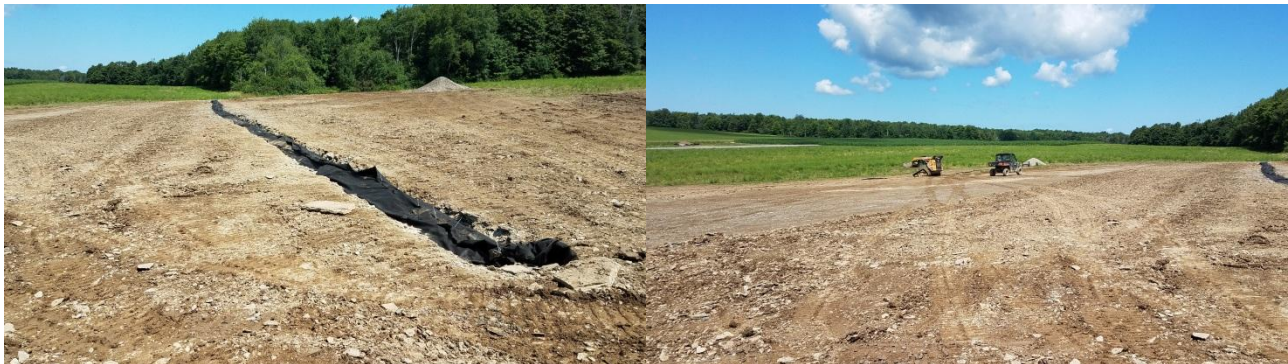
Construction was taking place on the site that involved trenches with stone enveloped with fabric. These appear to be level lip spreaders.

Level Lip Spreader Installation

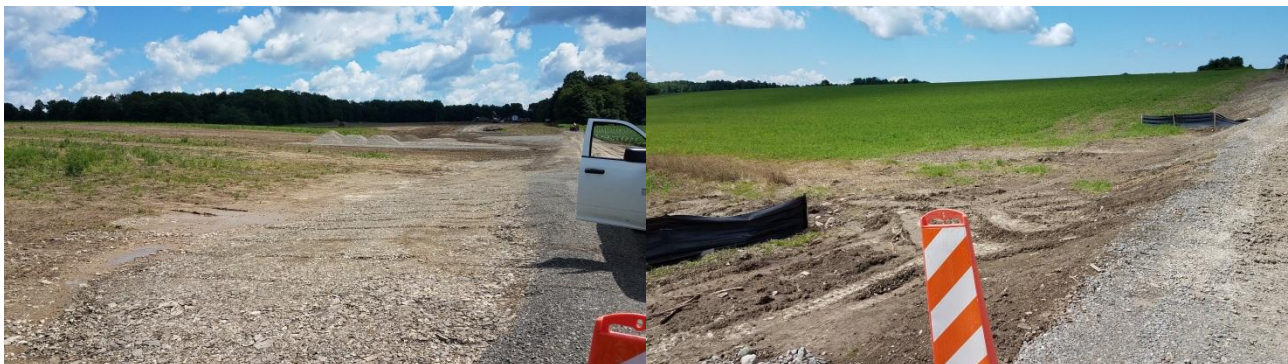
Along the sides of the access road there are exposed areas in multiple locations. These locations do not appear to be part of the access road and should be stabilized to prevent soil erosion and loss. (See attached photos)

Adjacent Area Along Access Road

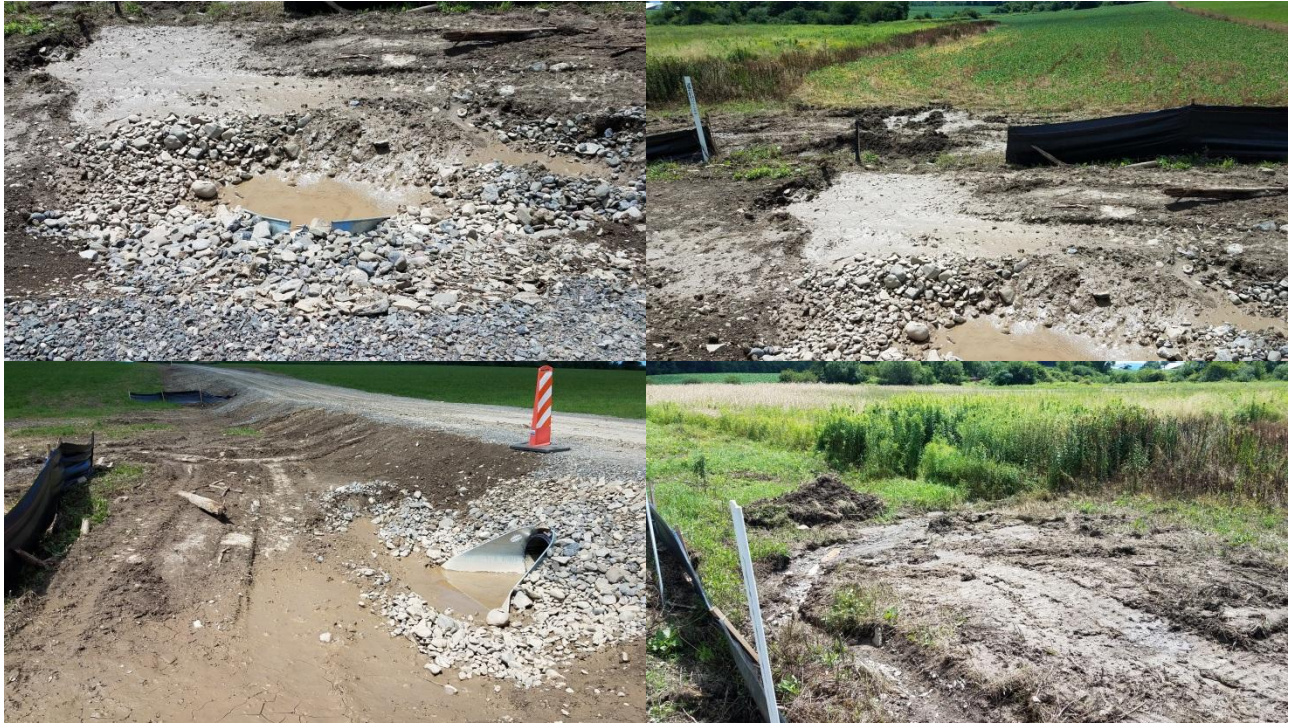
The drainage pattern and silt fence downslope of the first culvert pipe have been altered. Although silt fence is a BMP used as a soil erosion control measure, a section of silt fence has been removed to allow flow from the pipe outlet to the adjacent field and drainage channel. There was evidence of some soil deposition just beyond the pipe outlet. Some erosion and soil loss is also evident beyond the soil deposition. There is some slight channelization along the silt fence at this location due to water flow after leaving the pipe. (See attached photos)

## Outlet Location of Culvert Pipe

5. Continued monitoring of the culvert pipe outlet and adjacent area should be conducted. If soil deposition and erosion continue to occur, adjustments need to be made promptly to mitigate any problems and prevent worsening the situation.
